# Lidar mapping of faults in Houston, Texas, USA

## ABSTRACT

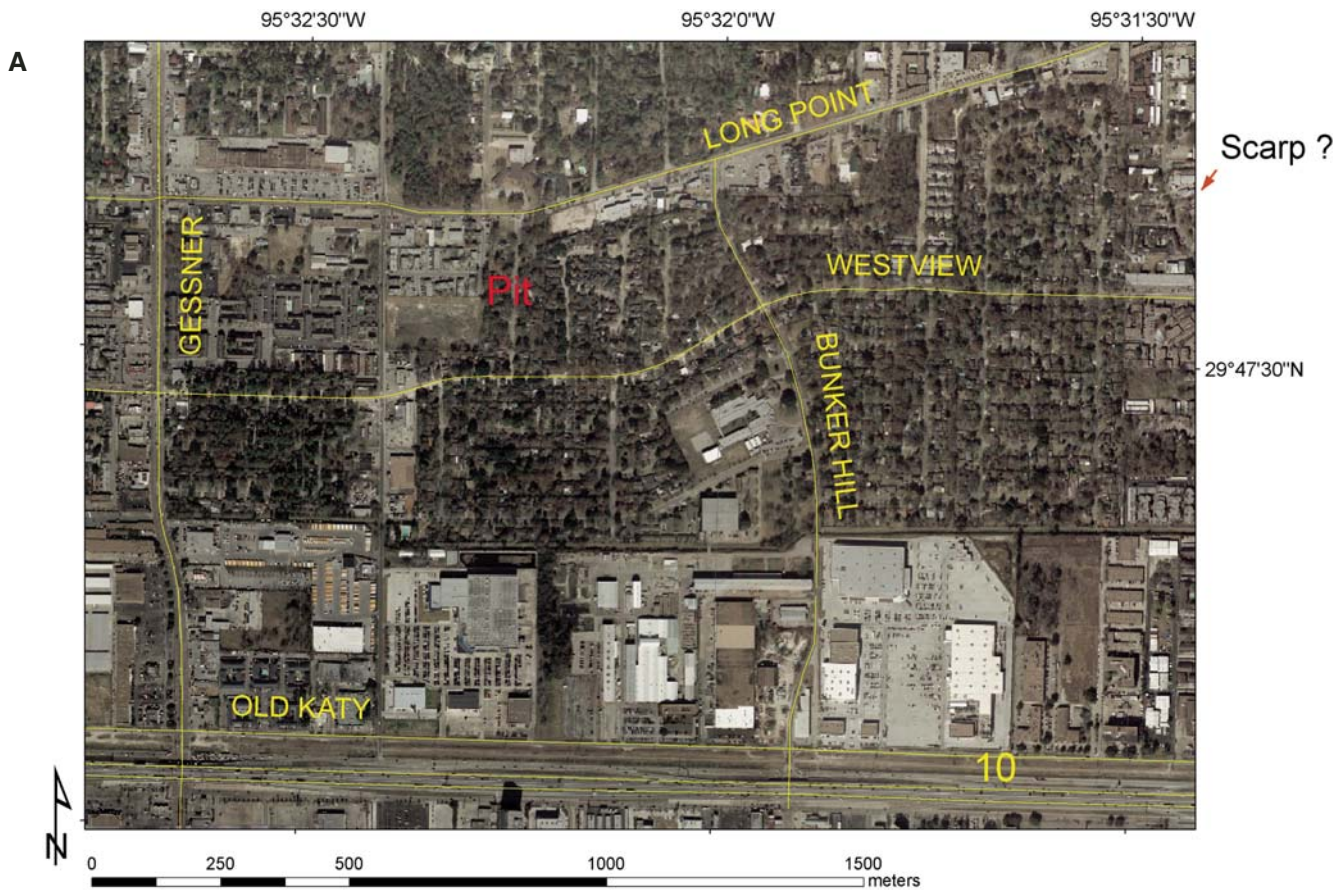
**Figure 7.** Comparison of orthophoto with lidar for fault detection. Location of map is shown in Figure 4. (A) Hillshade of lidar DEM. The fault is clearly visible trending west to east through the pit. (B) The Long Point Fault is not visible in the orthophoto, except for a slight change in tone within a water detention pond (pit), built on a site previously occupied by an apartment complex.

Lidar imagery emphasizes elevation differences, such as scarps. Aerial photos, in contrast, often show differences in vegetation on the upthrown and downthrown sides of the scarp because the downthrown side is typically wetter. The Long Point Fault can be clearly seen in the lidar image (Fig. 7A), but it cannot be seen in the orthophoto (Fig. 7B).

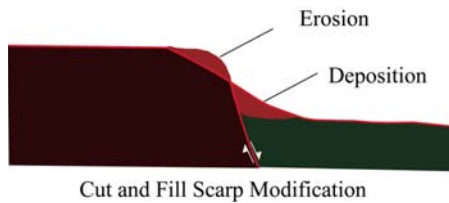
**Figure 8. Model for scarp formation (after Verbeek and Clanton, 1979). In this cut-and-fill process, erosion removes material from the footwall and deposits it on the hanging wall.**

In some places, the elevation transition across the scarp is broad and gently dipping. Figure 8 shows one model for this geometry. Erosion removes material from the footwall and

deposits it on the hanging wall (Verbeek and Clanton, 1979). Deformation near the surface results in a zone of shear in the unconsolidated sediments, rather than a distinct fault (Thomas and Nunn, 2006). Erosional leveling and distributed deformation can both contribute to scarp morphology.
