# Integrated Geophysical Studies Over an Active Growth Fault in Northwest Houston, Texas

by *Mustafa Saribudak*, Environmental Geophysics Associates  
and *Bob Van Nieuwenhuise*, Earth-Wave Geosciences, LLC.

*This paper presents and evaluates the use of four noninvasive geophysical methods for imaging the Willow Creek growth fault that cuts across Highway 249 in the northwest Houston, Texas, area.*

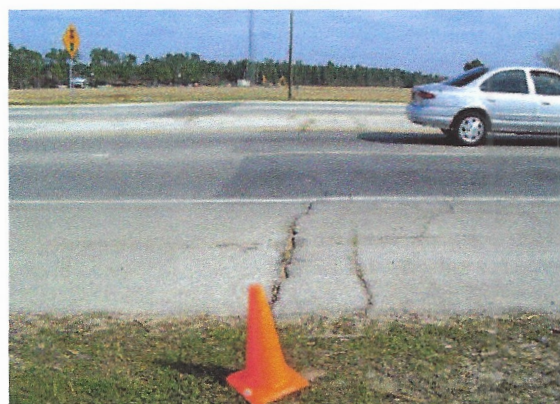
Fig. 3. View looking east of the trace of the Willow Creek fault as it crosses Highway 249. The fault is marked by the pavement cracks and asphalt patches.

The Willow Creek Fault crosses Highway 249 about 300 feet north of the Willow Creek Bridge, where it trends in the NE-SW direction and dips to the north (Figure 2). This fault is listric and antithetic to the south-dipping regional Tomball Fault about 5 miles to north. A discrete pavement break crossing both south- and north-bound lanes of Highway 249 clearly marks the presence of the fault (Figure 3).

Many fractures adjacent to and across the bridge may be related to the fault. A GPR survey profile near the north end of the bridge (Figure 4) indicates a significant disturbed zone next to the bridge. We also collected GPR data across the fault scarp, which is visible on the road (see the fault scarp in Figure 3); but the GPR data did not show any anomaly across this scarp. However, the GPR data did detect differential subsidence between the bridge
