# Resistivity Imaging and Natural Potential Applications to the Antioch Fault Zone in Onion Creek, Barton Springs Segment of the Edwards Aquifer, Buda, Texas

Mustafa Saribudak<sup>1</sup>, Brian Hunt<sup>2</sup>, and Brian Smith<sup>2</sup>

## ABSTRACT

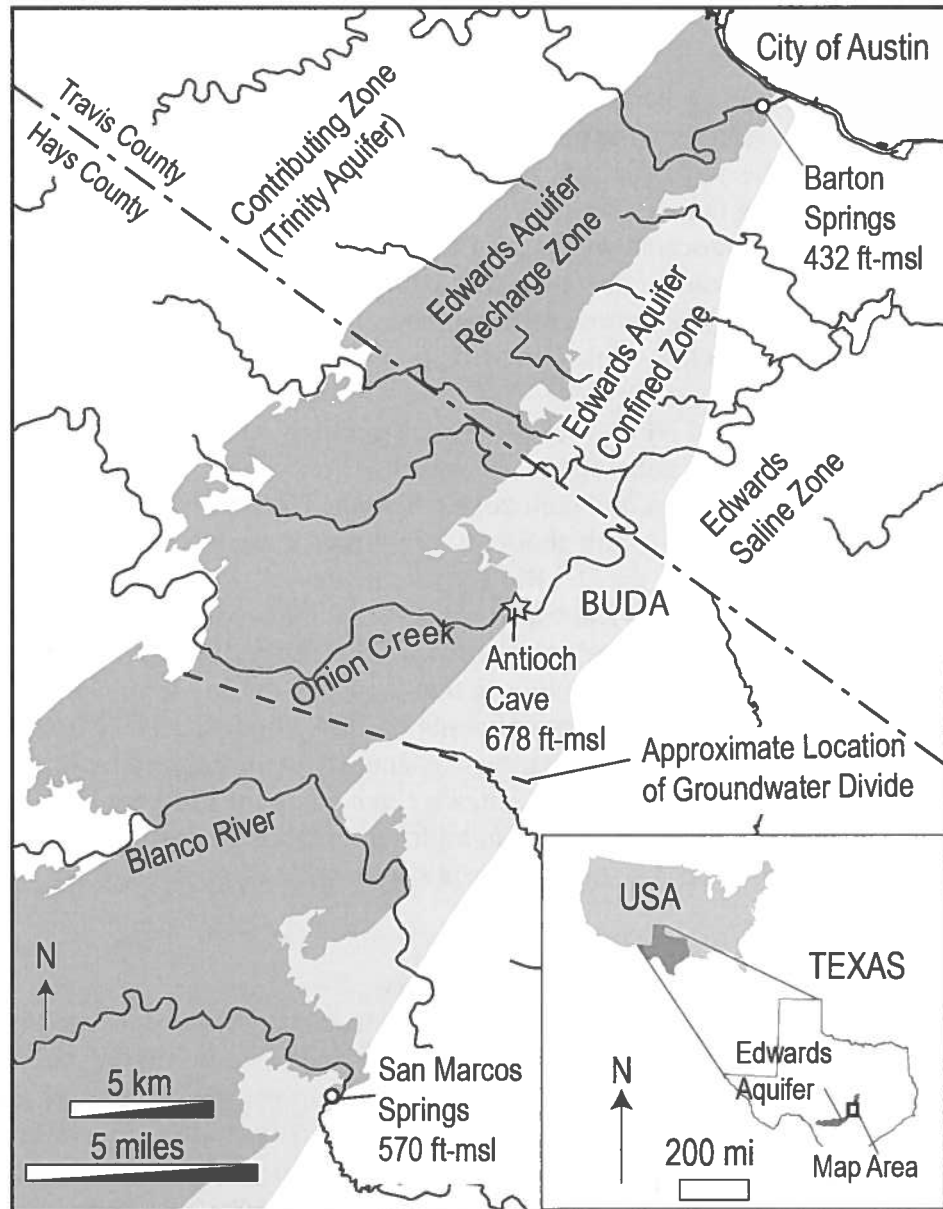
Figure 1. Site map indicating the location of Antioch Cave in the Barton Springs Segment.

The study area is located in the Barton Springs segment of the Edwards Aquifer and in the vicinity of Antioch Cave, which is located within Onion Creek and near the town of Buda (Figure 1). The study area traverses the eastern-most edge of the recharge zone and the confined zone of the Edwards Aquifer (Figures 1 and 2). Antioch Cave is the largest capacity recharge feature within

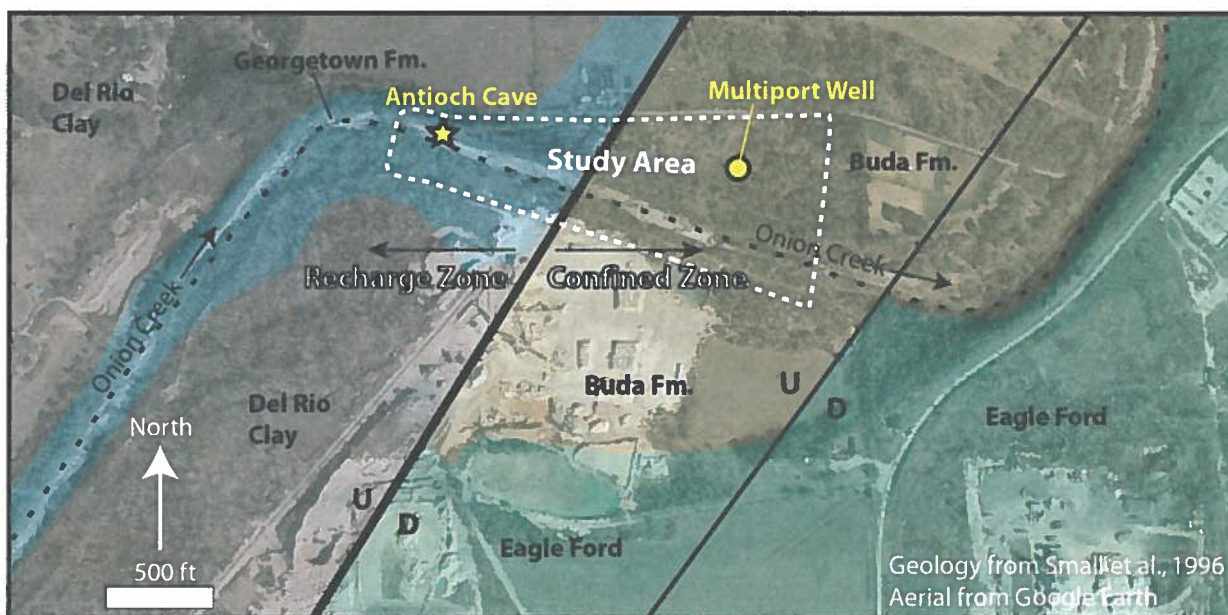
Figure 2. Bedrock geologic map of the geophysical study area, that is shown with a dashed white line. Note the location of the Antioch Cave to the west in the Onion Creek bed. Geology from Small et al., 1996.

Figure 2 displays the general bedrock geology of the study area and beyond. The map indicates the location of Antioch Cave and a significant fault in the middle of the map that is the boundary eastern boundary of the recharge zone.

the southeast. The elevation of the top of the Edwards Group is known from exposures within Antioch Cave (639 ft-msl) and also from borehole geophysical logs from the multiport well (538 ft-msl) indicating about 100 ft of throw across the mapped fault (Figure 2).

Figure 2 illustrates the fault and fracture control on the geomorphology of Onion Creek in the vicinity of the study area. The creek trends to the northeast for several thousand feet, makes a right angle turn and extends linearly to the southeast for several more thousand feet, and makes another right angle bend back to the original northeast trend. The northeast trend of the creek is parallel to the regional strike of Balcones faulting and also to the fault zones in the study area. The southeast trending section of the creek may be following a southeast trending fracture system or faulting, perpendicular to the dominant faulting trend. Conjugate fault and fracture systems are very common in the Balcones Fault Zone (Ferrill et al., 2004). Therefore, it is

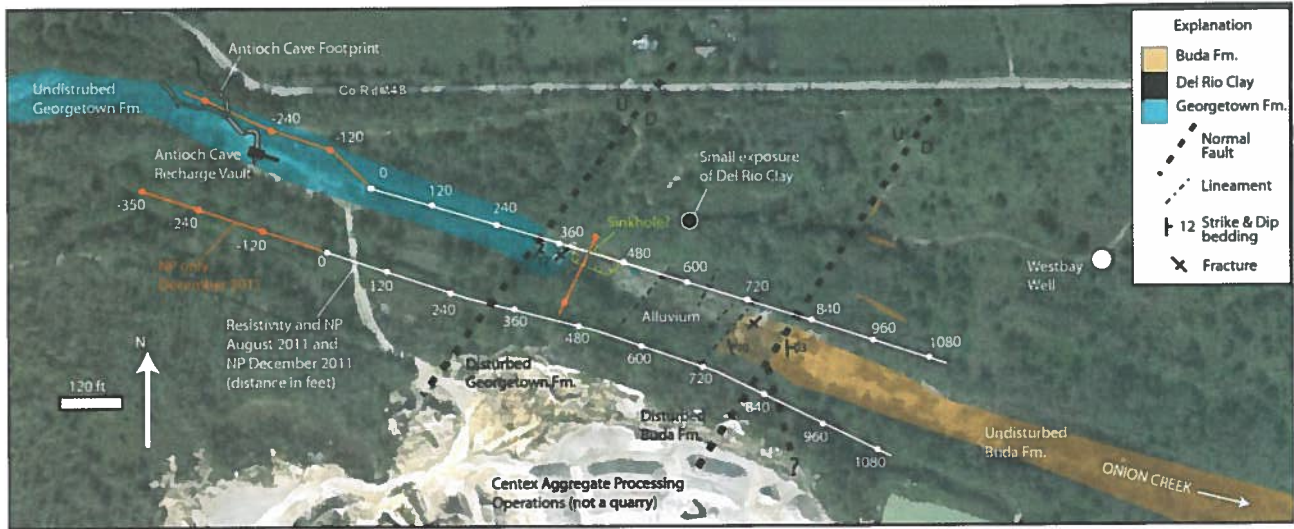
Figure 3. A detailed geological outcrop map of the geophysical study area. The map indicates two significant faults crossing the Onion Creek along with several lineaments. Note the locations of the geophysical profiles on the northern and southern banks of the Onion Creek. A natural potential survey was also performed across the suspected sinkhole.

The surface geological units in the study area consist of (from the bottom to the top, stratigraphically): the Georgetown Formation, Del Rio Clay, Buda Limestone, and alluvium. The Edwards Group limestones are not exposed at the surface in the study area. Much of the study area is overlain by Quaternary alluvium and terrace deposits and disturbed sediments resulting from gravel mining and associated activities. Figure 3 provides a detailed geological outcrop map of the study area, and shows the Antioch Cave, two major, normal, down-to-the-east faults along with several minor fractures, and an apparent sinkhole located in the bed of Onion Creek. A multiport monitor well shown in Figure 3 provides subsurface stratigraphic control for the eastern portion of the study area.

Two 1,100 ft resistivity and NP profiles were surveyed parallel to the southern and northern banks of Onion Creek separated by about 150 ft. Locations of these profiles are shown with white lines in Figure 3. The station spacing on both the resistivity and NP surveys was 20 feet. These surveys were conducted during the month of August, 2011 while record-setting hot and dry conditions prevailed across the entire State of Texas. For this reason, the authors performed additional NP profiles at the same station spacing in December, 2011 when recent rains had brought some relief from drought conditions to the area. These two NP profiles were extended about 400 feet further to the west to cover the location of Antioch Cave (Figure 3). In addition, a NP profile was surveyed across a suspected sinkhole feature within the bed of Onion Creek bed (Figure 3). It should be noted that the same base station was used on both NP surveys.

A total of three NP profiles were collected in the study area along the same transect as the resistivity. Two of the NP profiles were surveyed along the northern and southern banks of Onion Creek, and the third NP data set was collected across Onion Creek where an apparent sinkhole was located (see Figure 3). It should be noted that the NP profiles along the banks of the creek were collected twice (August, 2011 and December, 2011) to differentiate the effects of the drought and the rainy season on the NP data. In December, profiles were extended about 400 feet further to the west to cover the location of the Antioch Cave. The NP data collected in December are discussed below.

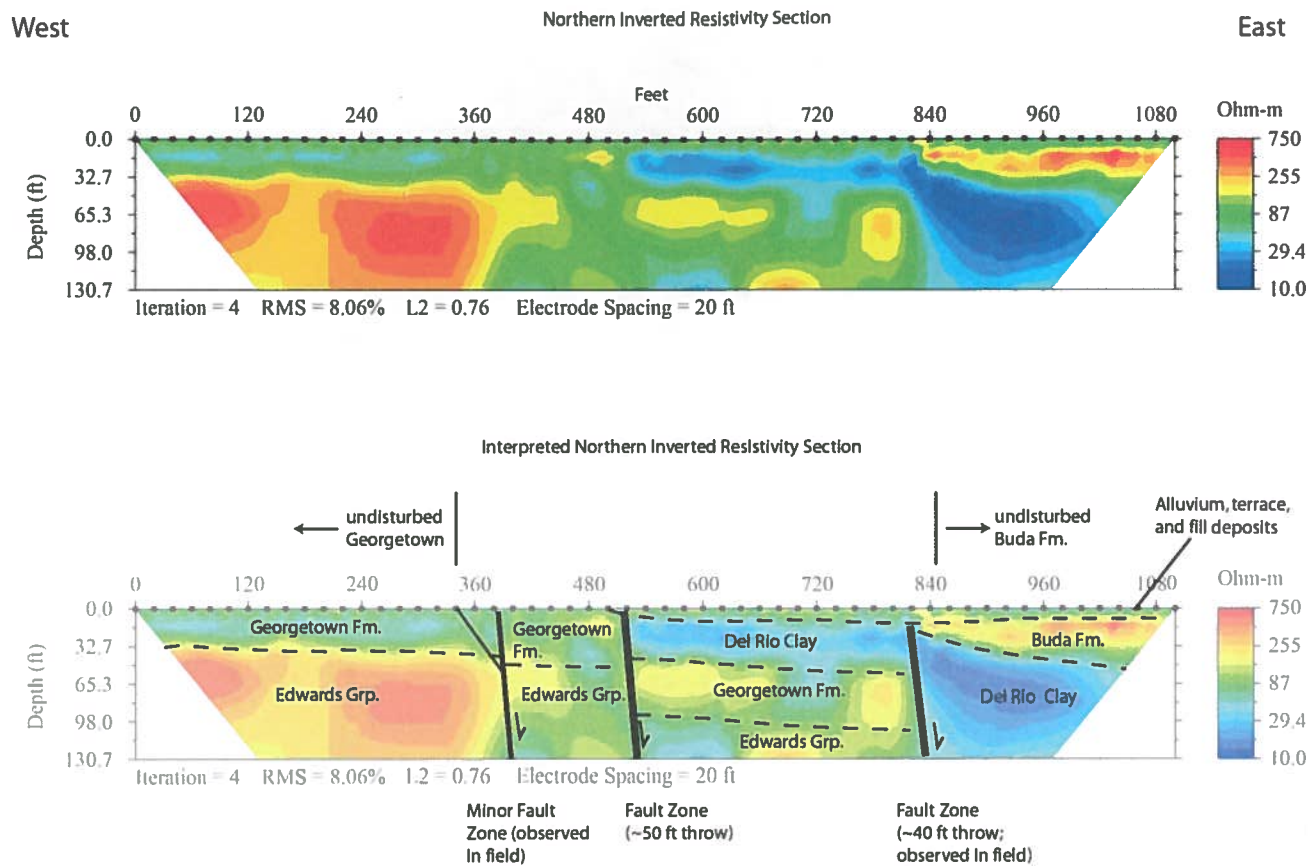
Figure 4. Resistivity imaging data along the northern bank of the Onion Creek. The lower and upper resistivity sections are given with and without the geological interpretation, respectively.

The resistivity profiles surveyed along the northern and southern banks of Onion Creek are given in Figures 4 and 5, respectively. Both figures include un-interpreted and interpreted resistivity sections. Resistivity values of the section are fixed between 10 and 700 Ohm-m, so that both resistivity sections can be correlated. Low resistivity values are shown with a blue color, which corresponds to the Del Rio Clay and the rest of the colors (green, yellow and red) colors are attributed Georgetown, Edwards Aquifer units, and Buda Limestone, respectively.

The resistivity imaging data along the northern bank displays the un-interpreted and interpreted resistivity data (Figure 4). The location of the outcropped Georgetown Formation is shown with the green color in the northwestern part of the profile. Underlying the Georgetown Formation are the Edwards Group units, which are displayed with yellow and red colors. The contact between the Edwards Group units and the Georgetown Formation appears to be quite well-defined. However, this conformity disappears at about 360 ft along the resistivity section where the first fault is observed in the field. Furthermore, there is a chaotic disturbed zone in the subsurface between stations 360 and 540 ft. In order to explain the resistivity structure of the geological units, two faults are projected at stations 360 and 540 ft. The first fault, which is observed in the field and by resistivity data at 360 ft strikes NNE, occurs within the Georgetown Formation. The second fault, predicted by the resistivity data, strikes to the NE and juxtaposes the Georgetown Formation and the Del Rio Clay. This second fault is obscured by alluvium at the surface. There is a relatively undisturbed resistivity section between stations 540 and 760 ft where a low resistivity unit (Del Rio Clay) is observed at about 15 ft below the surface. It should be noted that the surface geology between those stations is identified as alluvium. The resistivity

data indicate a significant fault at about station 820 ft which approximately corresponds to the observed fault location in the study area (Figure 3). The resistivity data indicate that the fault juxtaposes the Del Rio Clay against the Buda Limestone. The Del Rio Clay has a thickness of about 20 ft on the up-thrown side of the fault (northwest direction) whereas it has 100 ft apparent thickness on the downthrown side. In addition, the Del Rio Clay appears to be deformed and folded along the fault plane. This deformation could account for the increase in apparent thickness.

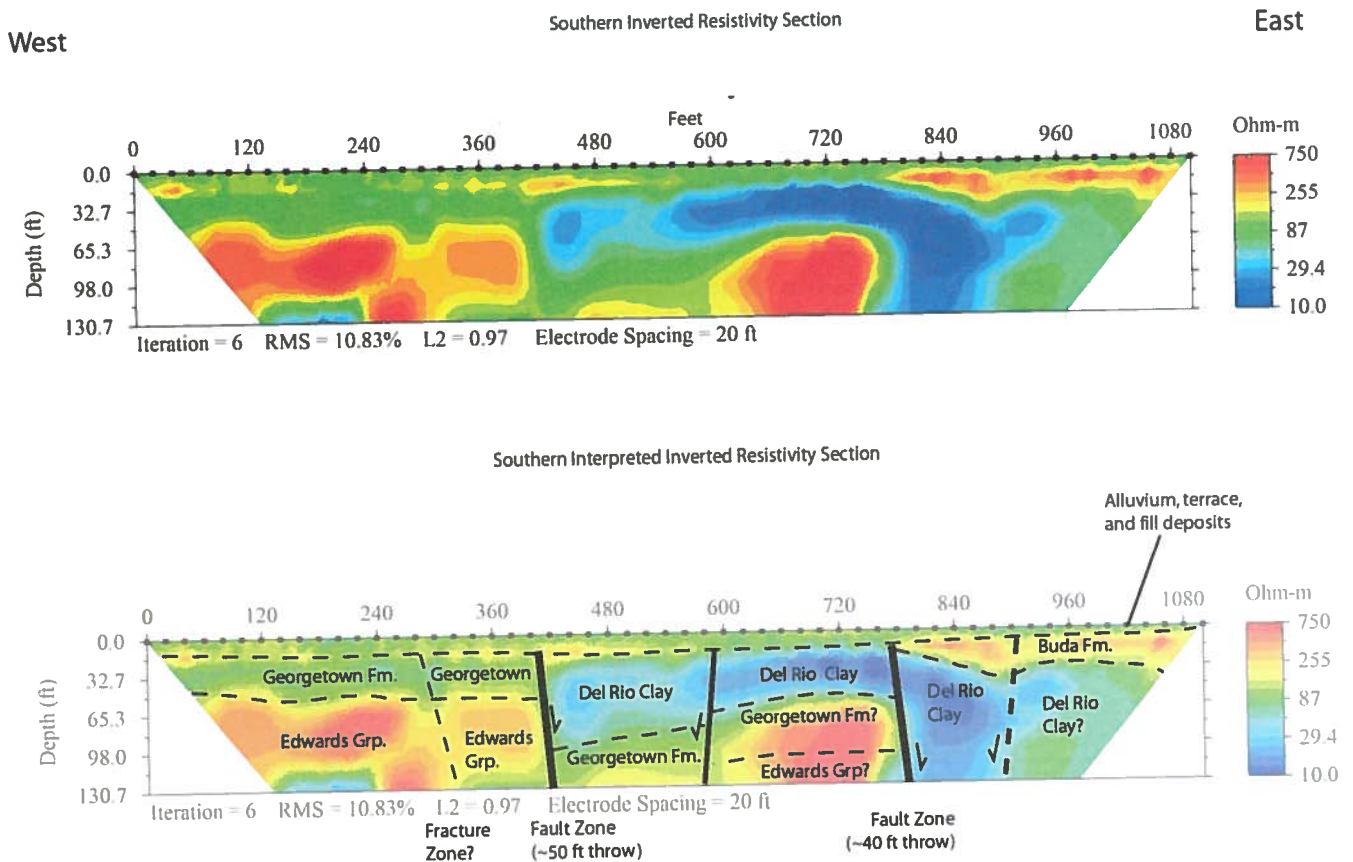
Figure 5. Resistivity imaging data along the southern bank of the Onion Creek. The lower and upper resistivity sections are given with and without the geological interpretation, respectively.

The resistivity data taken along the southern bank of Onion Creek are shown in Figure 5. The resistivity data indicate very similar anomalies that are observed along the northern bank profile. The resistivity data indicate a fault at station 400 ft which juxtaposes the Georgetown Formation and the Del Rio Clay. There is a highly disturbed zone between stations 360 and 600 ft where very low resistivity anomalies are observed. The second fault limiting the chaotic zone is located at station 600 ft. This fault strikes to the northwest and is interpreted as a down to the SE normal cross-fault (Figure 5). Between stations 600 and 740 ft the Del Rio Clay (blue color on the resistivity section) is observed at about 15 feet below the surface. The unit has a thickness of 20

ft and is underlain by the Georgetown Formation (green to red in color). The apparent increase in resistivity of the Georgetown Formation at this location is not clear. Either the Georgetown Formation is unusually thin and the red color corresponds to the Edwards Group, or there are significant voids or other factors influencing resistivity. Another significant fault is displayed at station 780 ft. This fault juxtaposes the Del Rio Clay and Buda Limestone. The Del Rio Clay appears to be deformed proximal to the fault plane producing an increase in apparent thickness. A change in the resistivity suggests the Del Rio Clay is pinched or faulted out at about 920 ft at a depth of 30 ft. It should be noted that the topographic elevation of station 960 ft is about 15 ft above the bed of Onion Creek where the Buda Limestone outcrops. Thus, we examined the bed of Onion Creek for a corresponding Del Rio Clay pinch out. A photograph taken at about station 840 ft shows horizontal Buda Limestone layers juxtaposed against steeply dipping Buda Limestone layers along what is interpreted to be a fault. The location shown in the photograph and the corresponding resistivity data, which are extracted from the original resistivity data, are given in Figure 6. It should be noted that the resistivity profile is reversed in direction to be compatible with the orientation of the photograph. In order to explain the termination of the Del Rio Clay, a fault is interpreted at station 920 ft.

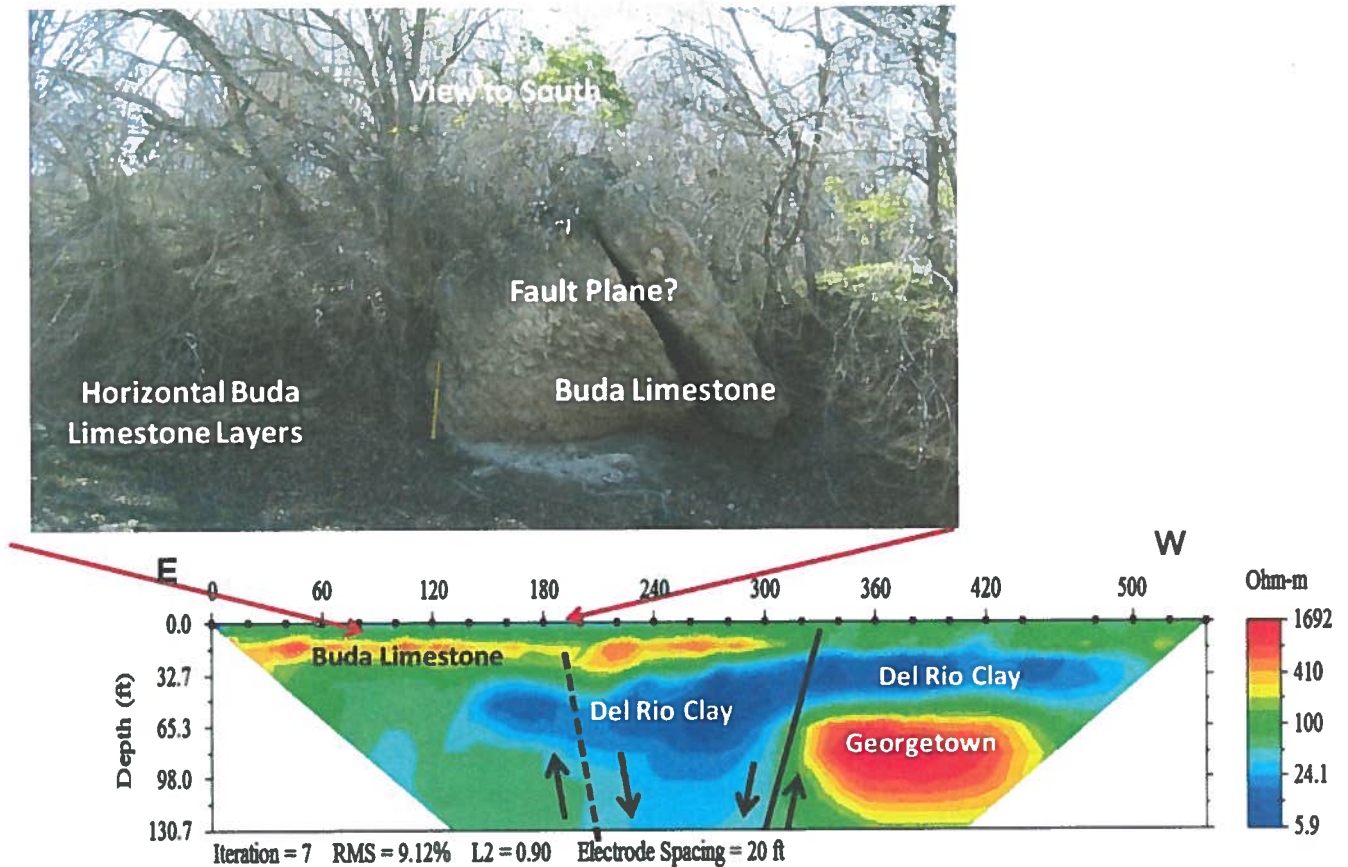
Figure 6. The photo shows steeply dipping Buda Limestone beds juxtaposed against the horizontal Buda Limestone beds. A fault is inferred at this location and corresponding to the location where the Del Rio Clay is terminated in the subsurface. A resistivity section (lower section), that is segmented from the original resistivity section (Figure 4) shows where the Del Rio Clay pinches out with respect to the field picture.

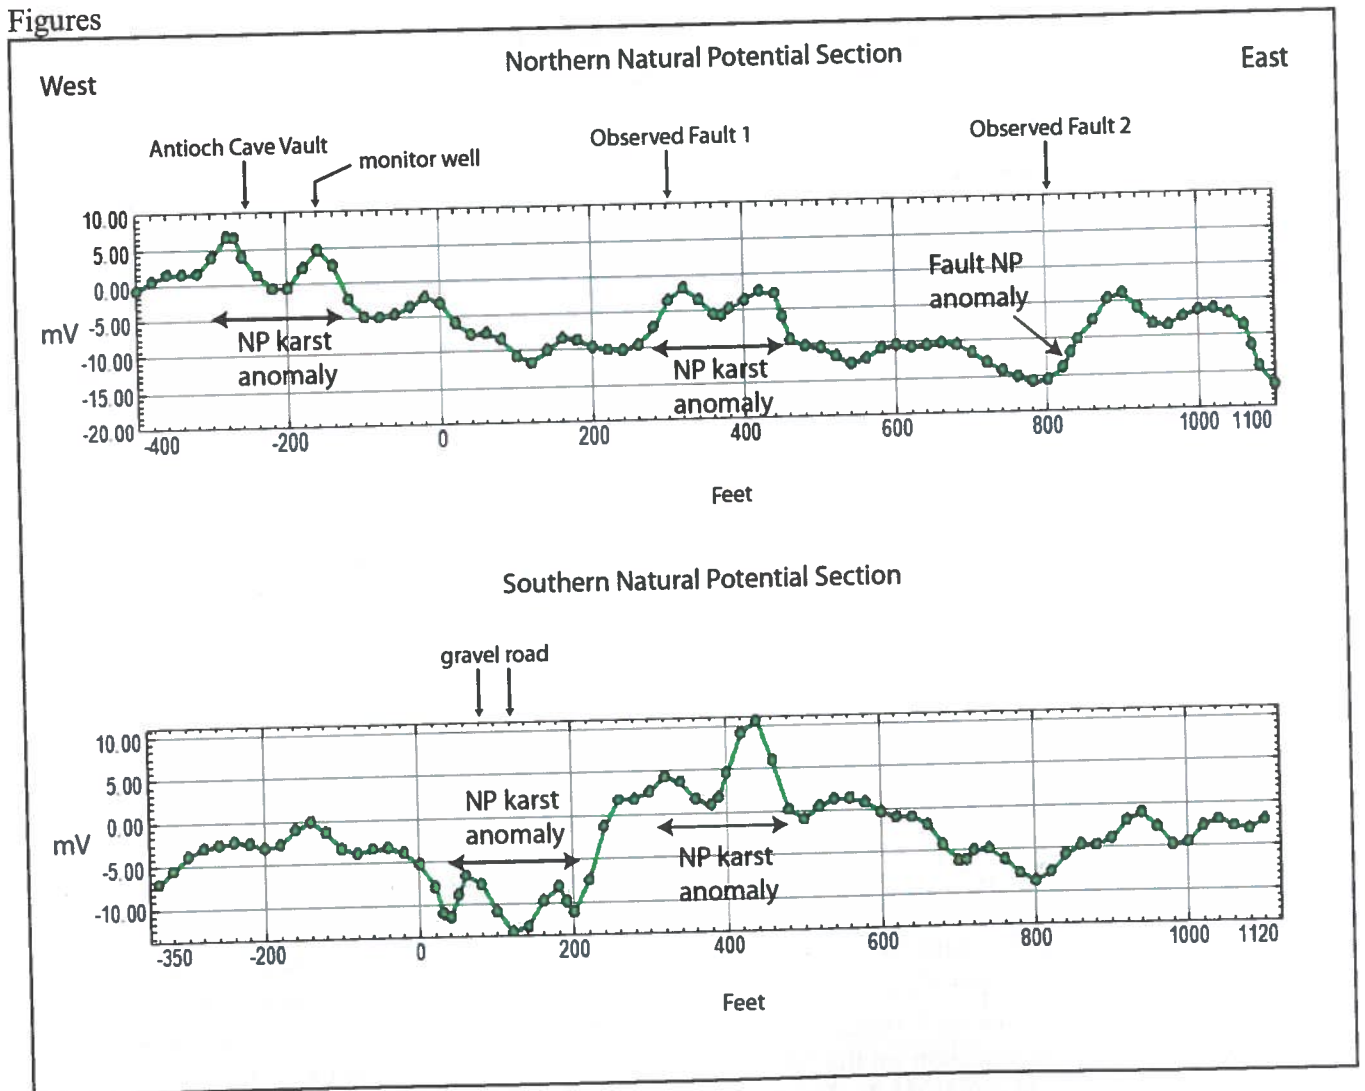
Figure 7. Natural potential data along the northern and southern banks of the Onion Creek. Note the locations of two significant faults observed in Figure 3. Significant NP anomalies are marked on both profiles. One of the NP anomalies located at station -160 ft along the northern bank of the Onion Creek was drilled down to 220 feet. Significant voids were encountered during the drilling.

Both NP data sets acquired along the northern and southern banks of Onion Creek during December, 2011 are shown in Figure 7. The northern data sets indicate karstic anomalies between stations -120 and -320 ft. It is known that Antioch Cave extends toward station -320 ft. The karstic anomaly observed at -120 ft could also be due to an unknown chamber of the cave. Furthermore, additional karstic anomalies are observed between 300 and 500 ft where the first significant fault is observed on the resistivity section (Figure 4). This fault juxtaposes the Georgetown Formation against the Del Rio Clay. In addition, a fault-like NP anomaly ("S" like anomaly) observed between stations 780 and 900 ft corresponds to where the second significant fault is observed. This fault brings the Del Rio Clay and Buda Limestone in contact.

The NP data collected along the southern bank of Onion Creek also indicates karstic anomalies (see lower NP cross-section in Figure 7). A pair of high and low NP anomalies are observed between stations 0 and 200 ft. These anomalies do not exist on the corresponding stations of the northern NP section. A significant NP gradient is observed between stations 200 and 300 ft and more NP anomalies are located between stations 300 and 500 ft. Locations of all these NP anomalies correspond to the significant fault or fault zone are observed on the geological map and the resistivity sections (Figures 3 and 5).

Since the geophysical work (August 2011) was done, a monitoring well recently (7/15/2013) drilled on a NP anomaly near the Antioch Cave (see Figures 7 and 9) along the northern bank of Onion Creek. The purpose of the installment of the monitoring well near the Antioch Cave recharge structure was to measure the impact of recharge entering the cave on water levels in the Edwards Aquifer. When water is flowing in Onion Creek, high rates of recharge take place along Onion Creek and particularly into Antioch Cave that is situated in the bed of the creek. During periods of high recharge, a significant groundwater mound develops in this area.

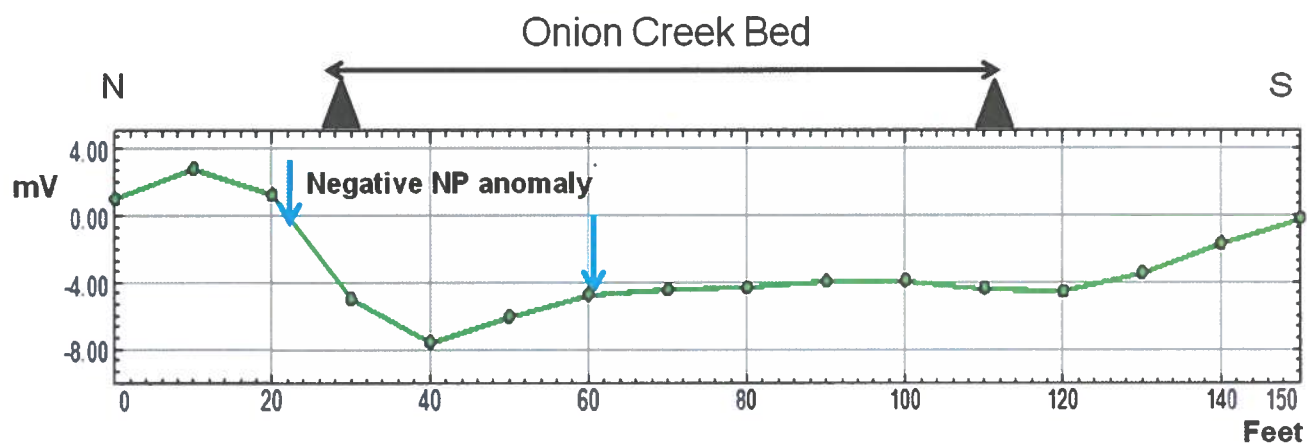
Figure 8. Natural potential data across the Onion Creek where a sinkhole is suspected. Note the negative NP anomaly near the northern bank of the Creek.

Figure 8 shows the NP profile surveyed across an apparent sinkhole which is located in Onion Creek between northern transect stations 360 and 380 ft (Figure 3). The NP data indicate a significant negative anomaly ( $\sim -8$  mV) between stations 20 and 60 ft where the sinkhole is located. This anomaly can be explained by the downward movement (recharge) of groundwater into the sinkhole.

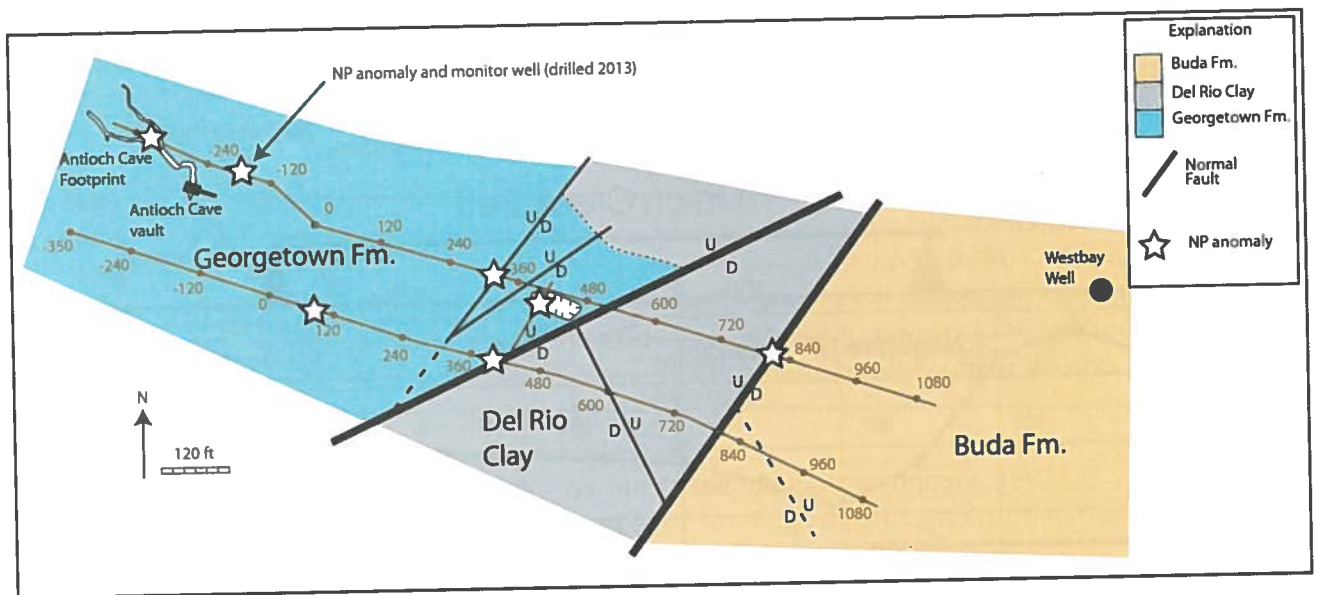
Figure 9. Revised geological outcrop map based on the geophysical data. Note the locations of the NP anomalies which are shown by the stars, and a newly drilled monitoring well location on the NP anomaly located at station -160 ft along the northern bank of the Creek.

Geological information inferred from the resistivity and the NP data (Figures 4, 5, and 7) was combined with the geological map of the study area (Figure 3) and is presented in Figure 9. Based on the resistivity data, the locations, orientations, and geometries of the fault zone crossing Onion Creek are better defined.
